INDOOR AIR QUALITY ASSESSMENT

**Lincoln Park Community School at Thurston St
50 Thurston Street
Somerville, MA 02145**

Prepared by:
Massachusetts Department of Public Health
Center for Environmental Health
Emergency Response Indoor Air Quality Program
August 2006

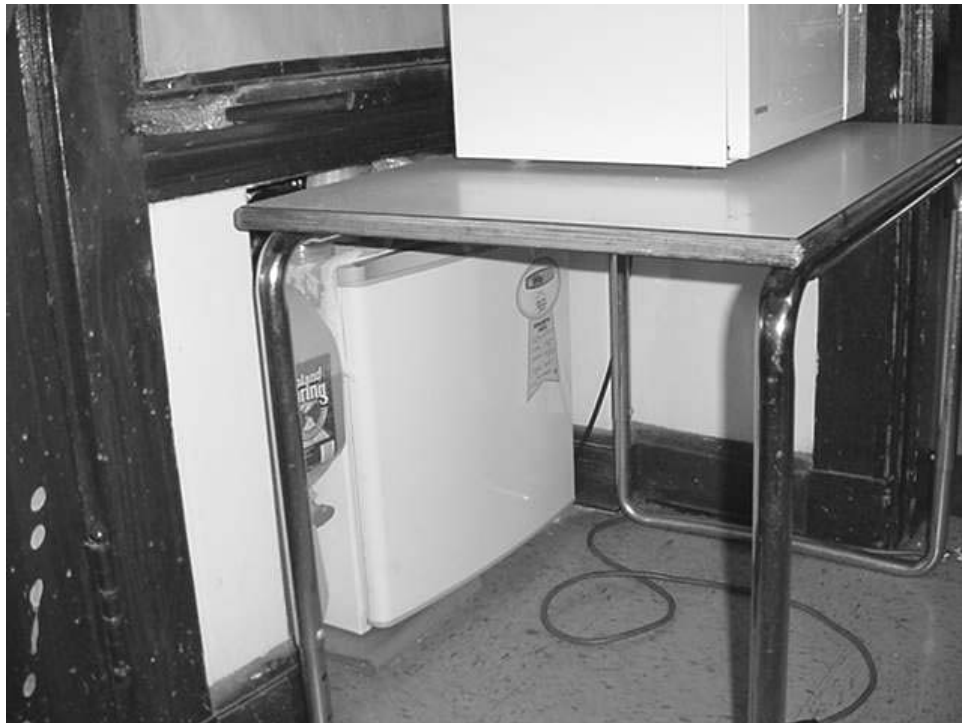
Picture 1

opening in the wall (Picture 1). Airflow within the duct is regulated by a louver with an attached pull-chain. In one room, the wall opening was sealed. If the system is not in use, consideration should be given to sealing all exhaust vents to prevent backdrafting and movement of materials into occupied areas. Without sufficient supply and exhaust ventilation, normally occurring environmental pollutants can build up and lead to air quality/comfort complaints.

Exhaust vent cubby with materials stored in cut out area

6. If not in use, consideration should be given to sealing all gravity exhaust vents to prevent backdrafting and movement of materials into occupied areas.

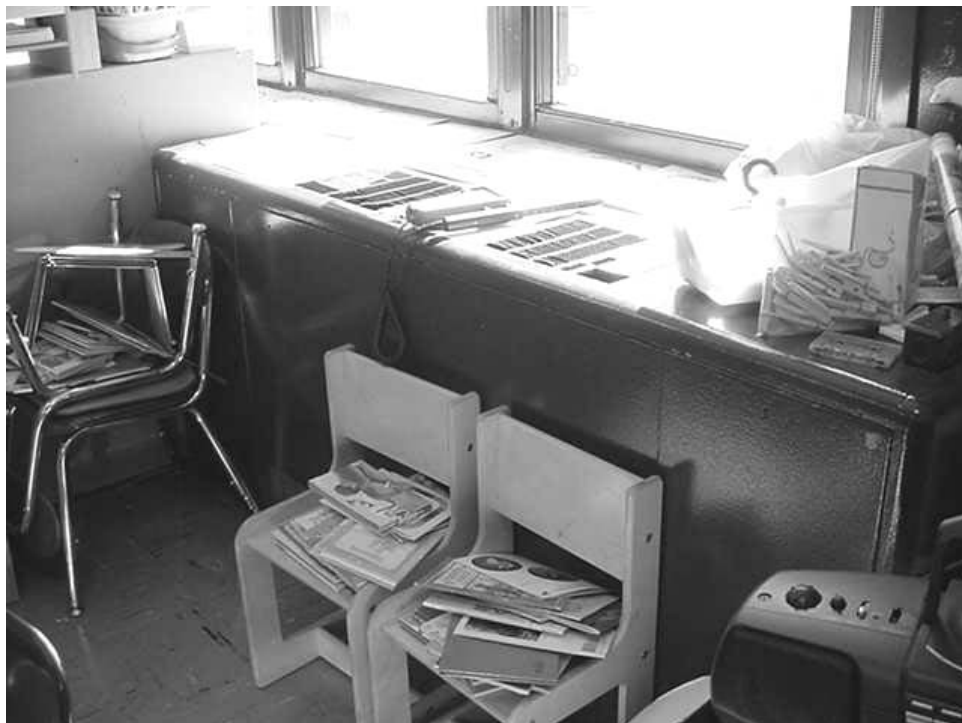
Picture 2

Unit ventilator (univent) systems provide mechanical ventilation to classrooms in the 1950s addition (Pictures 2 and 3). A univent draws air from outdoors through a fresh air intake located on the exterior wall of the building (Picture 4) and returns air through an air intake located at the base of the unit ([Figure 1](#)). Fresh and return air are mixed, filtered, heated and/or cooled and provided to classrooms through a diffuser located on the top of the unit. Mechanical exhaust ventilation in these classrooms is provided by exhaust vents located in closets (Picture 5). These vents are ducted to a rooftop exhaust fan (Picture 6). At the time of the assessment, classroom univents and exhaust systems were deactivated in all areas, therefore no means of mechanical ventilation were being provided.

1950s univent

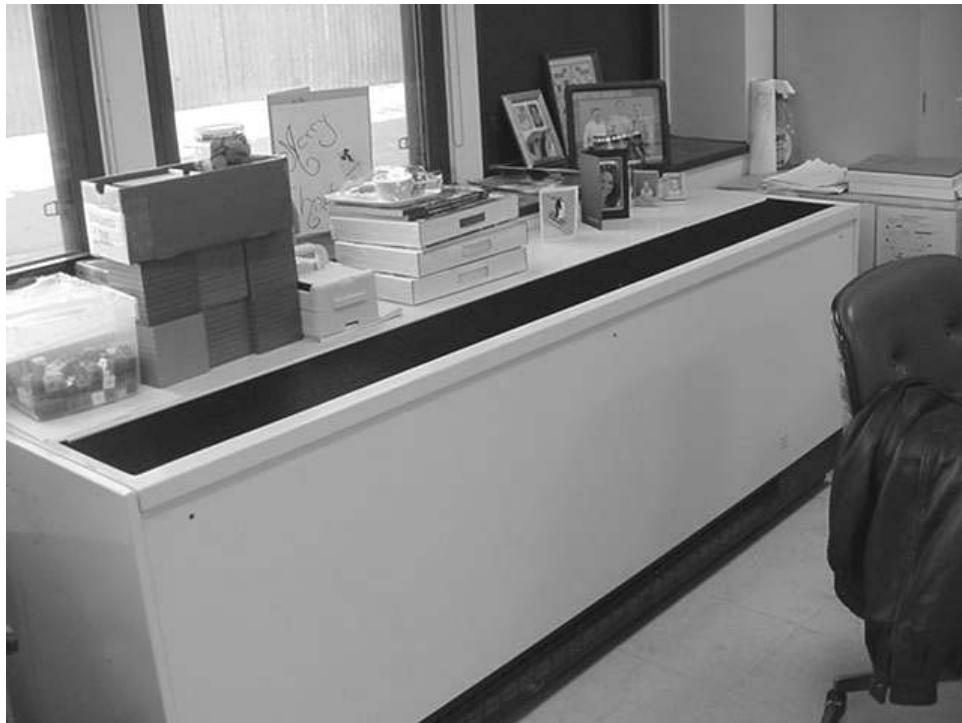
Picture 3

univent retrofitted after fire

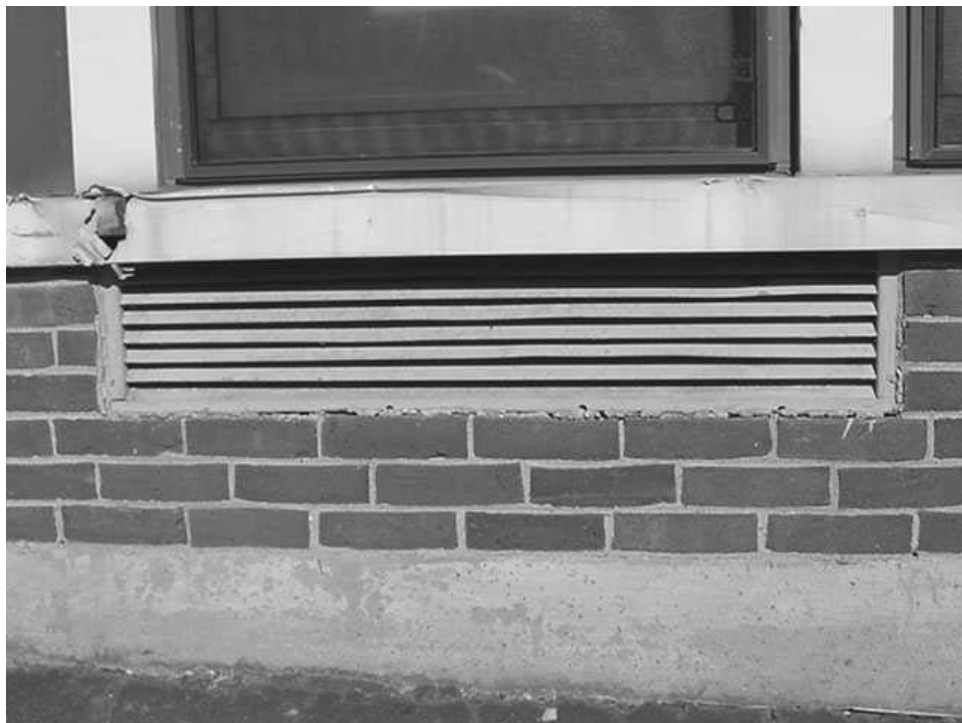
Picture 4

A number of breaches were observed around the exterior of the building. CEH staff observed damaged aluminum siding and window casing (Pictures 4 and 14). Damage to brickwork, missing/damaged mortar, as well as a broken window were also observed along the building exterior (Pictures 15 to 17). Breaches in the building envelope can provide a means of water penetration and may also provide a means of egress for pests/rodents into the building.

Univent fresh air intake

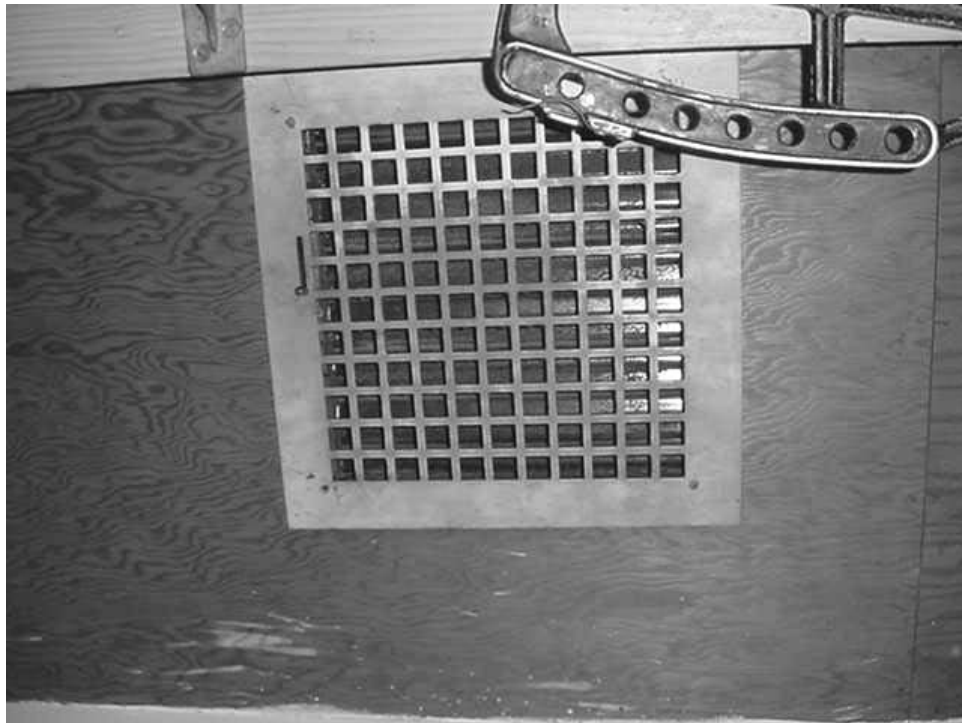
Picture 5

Closet exhaust vent

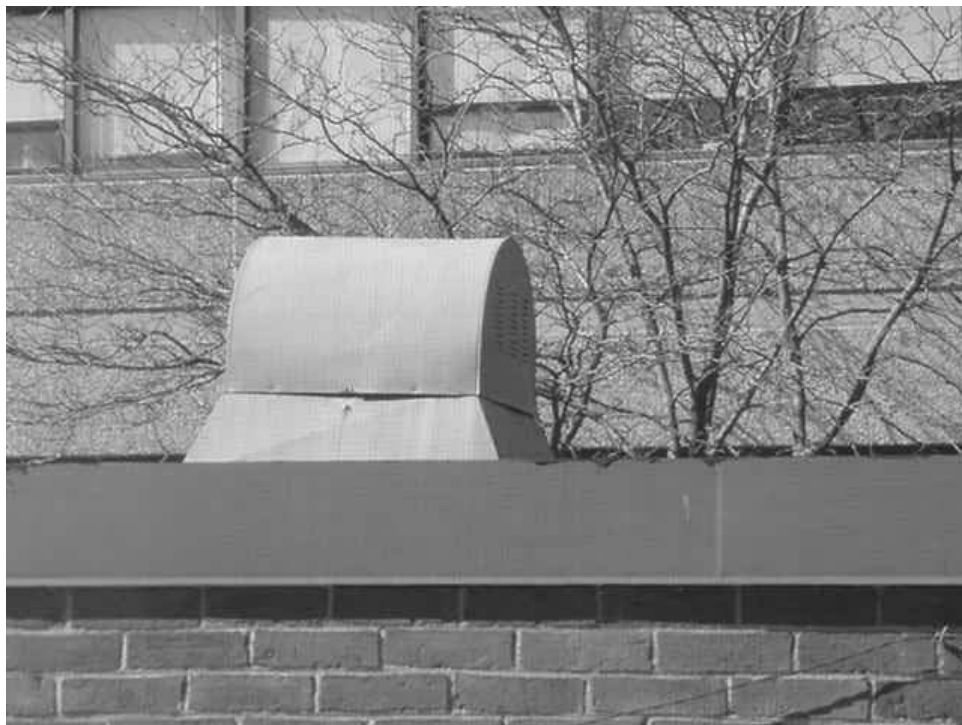
Picture 6

Rooftop mounted exhaust fan

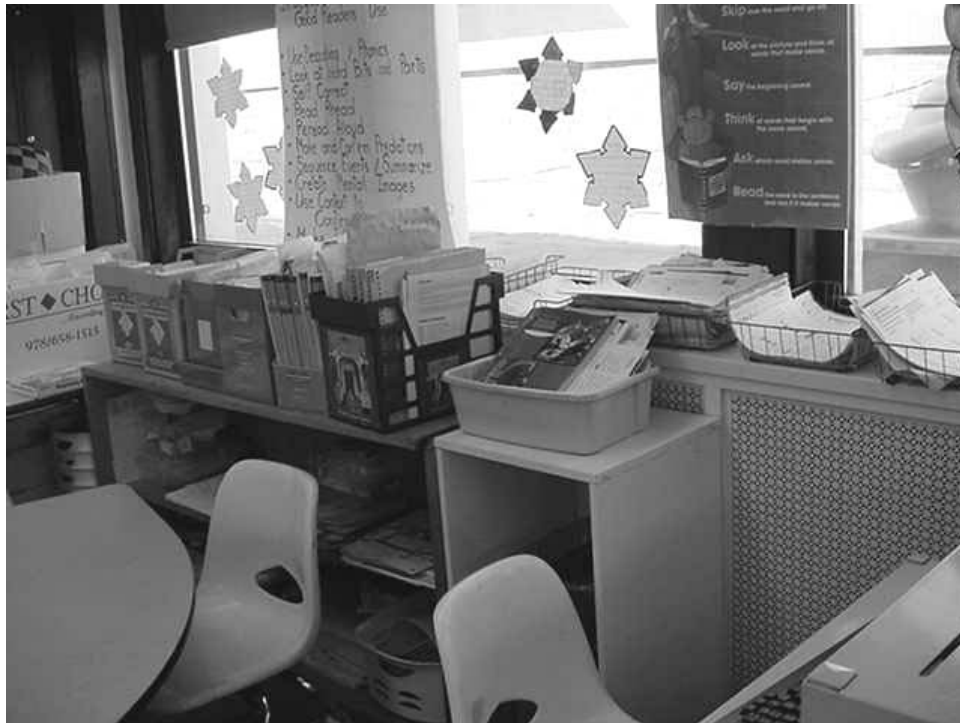
Picture 7

temperature control issues. CEH staff observed a number of rooms where items were blocking radiators (Picture 7), thereby preventing movement of heat into classrooms. In many cases concerning indoor air quality, fluctuations of temperature in occupied spaces are typically experienced, even in a building with an adequate fresh air supply. In addition, it is difficult to control temperature and maintain comfort without an operating mechanical ventilation system.

Materials placed in front of radiators

8. Remove blockages to radiators to allow even warming of classrooms and to prevent fire hazards.
9. For buildings in New England, periods of low relative humidity during the winter are often unavoidable. Therefore, scrupulous cleaning practices should be adopted to minimize common indoor air contaminants whose irritant effects can be enhanced when the relative humidity is low. To control for dusts, a high efficiency particulate arrestance (HEPA) filter equipped vacuum cleaner in conjunction with wet wiping of all surfaces is recommended. Avoid the use of feather dusters. Drinking water during the day can help ease some symptoms associated with a dry environment (throat and sinus irritations).

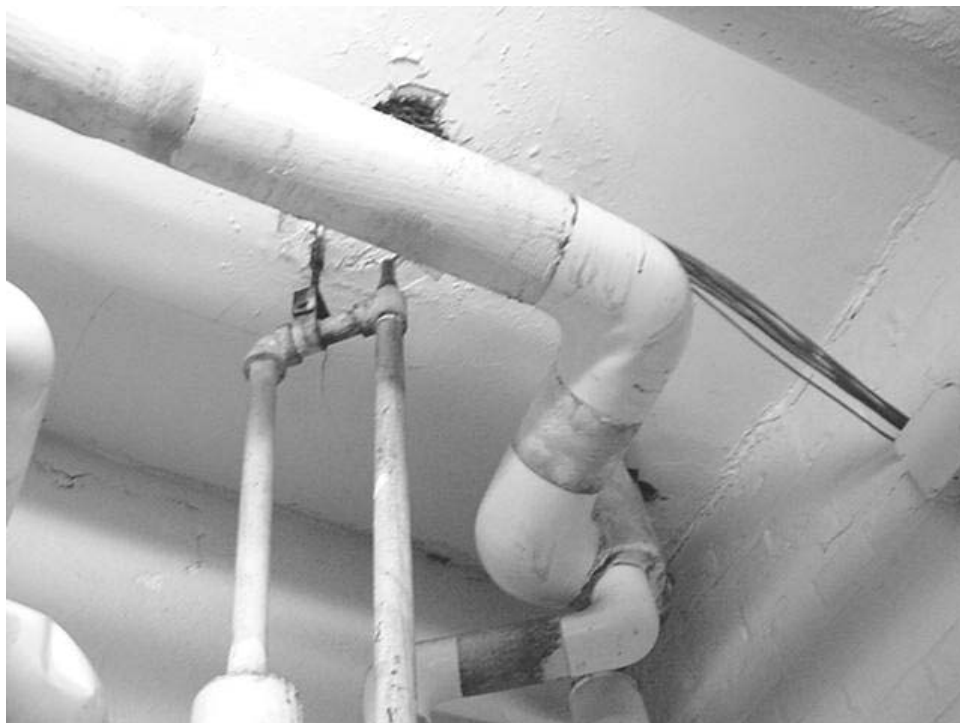
Picture 8

According to staff, the school experienced a steam leak in the basement storage area in early 2006 (Picture 8). The storage area was constructed prior to the LPCS population moving into the school. The structure consists of wooden supports and gypsum wallboard (GW) walls. As a result of the leak, walls and other materials in the storage room were damaged. At the time of the assessment, CEH staff observed mold growth on the GW (Picture 9), as well as on the wooden support beams and the door (Picture 10). CEH staff recommended immediate removal and replacement of damaged material (i.e., GW, wooden supports and the door) in accordance with US EPA guidelines. CEH staff also recommended that non-porous physical education equipment (i.e., mats) be cleaned with an appropriate antimicrobial.

Steam leak causing damage in storage room

10. Remove and discard all mold contaminated building materials (i.e. walls, doors) in the basement storage area in accordance to guidelines outlined in “Mold Remediation in Schools and Commercial Buildings” published by the US Environmental Protection Agency (US EPA, 2001). This document can be downloaded from the US EPA website

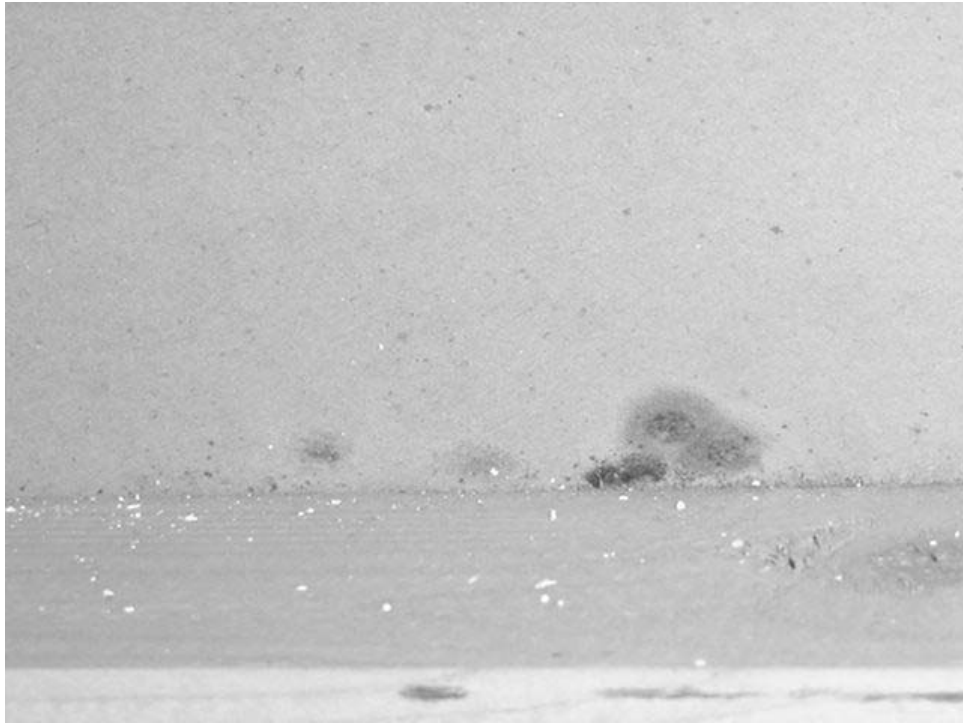
Picture 9

Mold growth on gypsum wallboard and wood supports

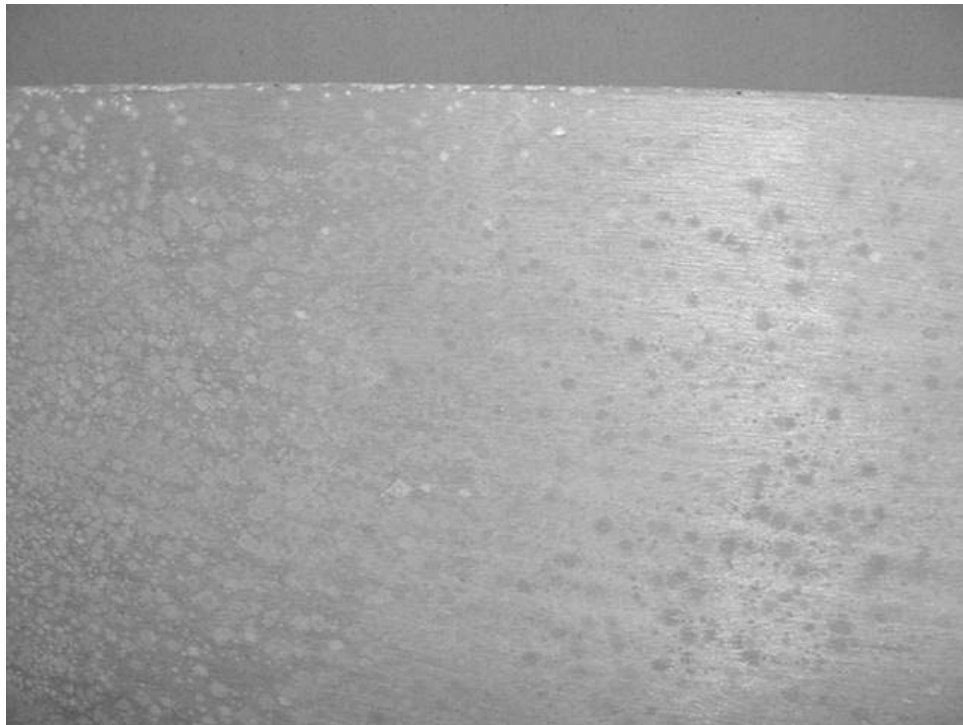
Picture 10

Mold growth on storage room door

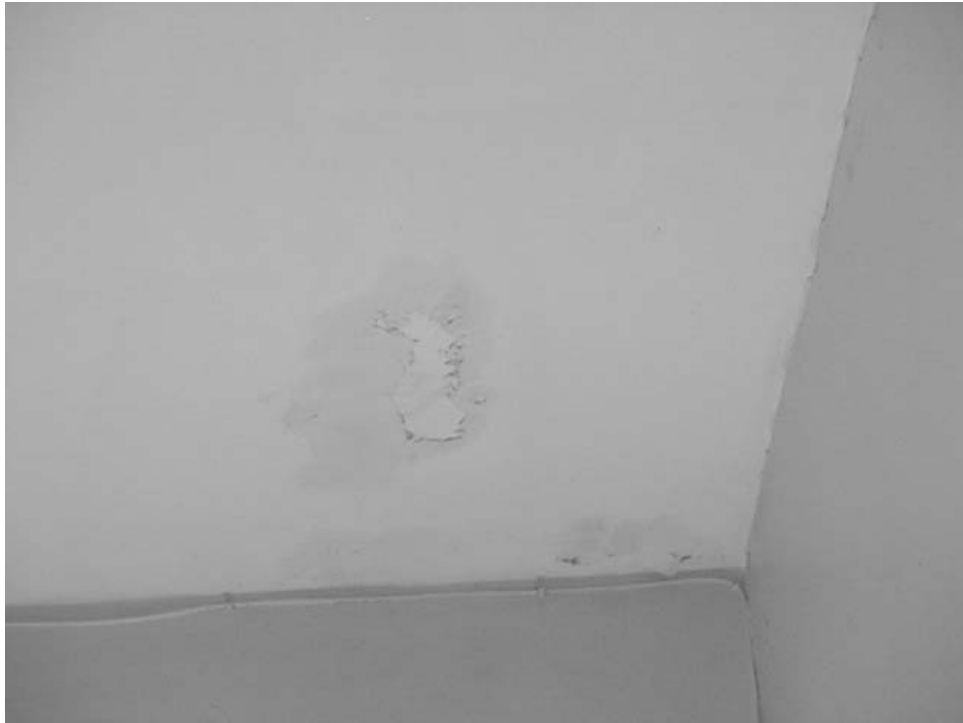
Picture 11

A few areas had water-stained ceiling plaster and water-damaged ceiling tiles (Pictures 11 and 12), which can indicate leaks from the roof or plumbing system. Plaster is not a medium for mold growth; however, dust on the surface and between paint layers can provide conditions for growth. Unlike plaster, water-damaged ceiling tiles can serve as a medium for mold and should be replaced after a water leak is discovered and repaired.

Water-damaged ceiling plaster

11. Ensure roof and/or plumbing leaks are repaired, and replace/repair water damaged building materials. Examine the area above and around these areas for mold growth. Disinfect areas of water leaks with an appropriate antimicrobial.

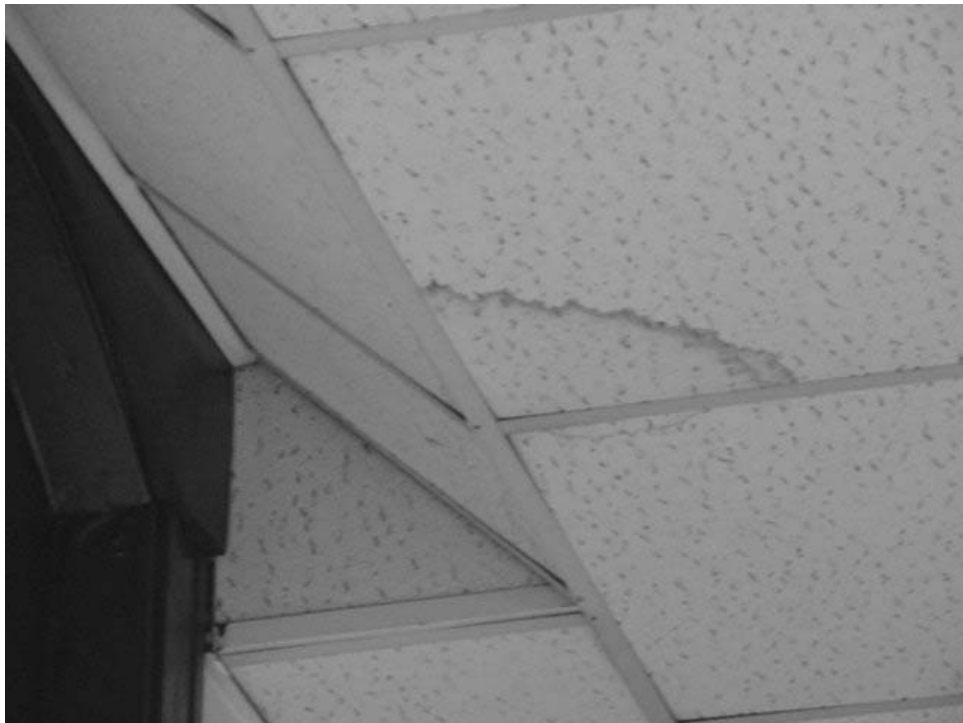
Picture 12

Water-damaged ceiling tile

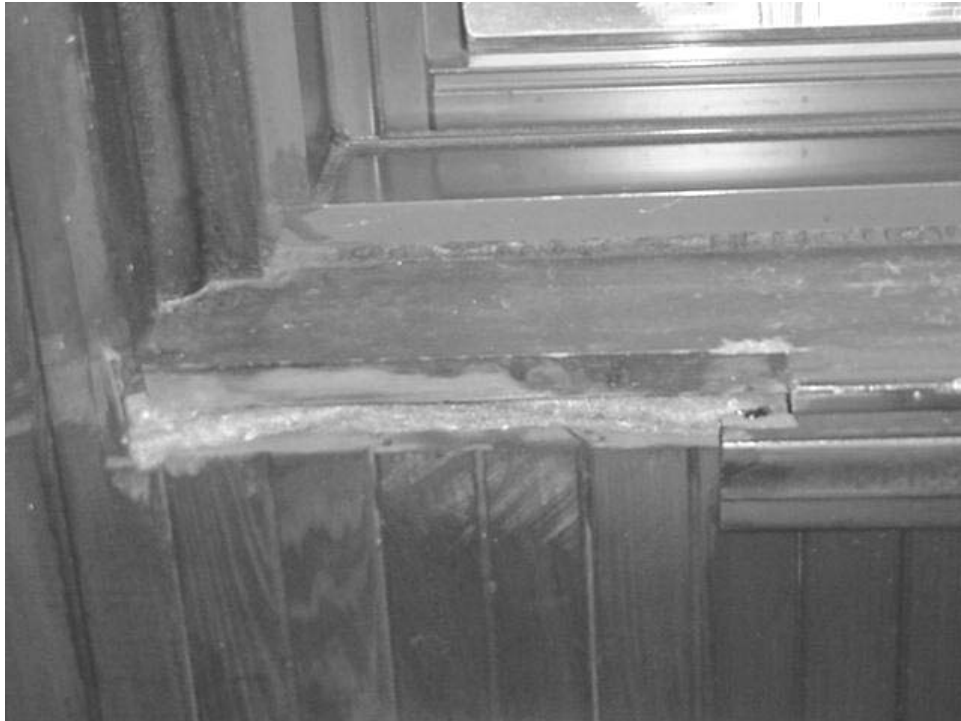
Picture 13

A water-damaged wooden window frame was observed in one classroom (Picture 13). Exposed fibrous insulation material was observed in this window frame. Fiberglass/insulation can be a source of skin, eye and respiratory irritation. If wetted repeatedly, these materials can also allow for mold growth.

Water-damaged window frame with exposed insulation

12. Repair window frames to prevent drafts and water penetration.
13. Repoint the building exterior to prevent water penetration.
14. Ensure all utility holes and breaches are properly sealed to prevent water or pest penetration.

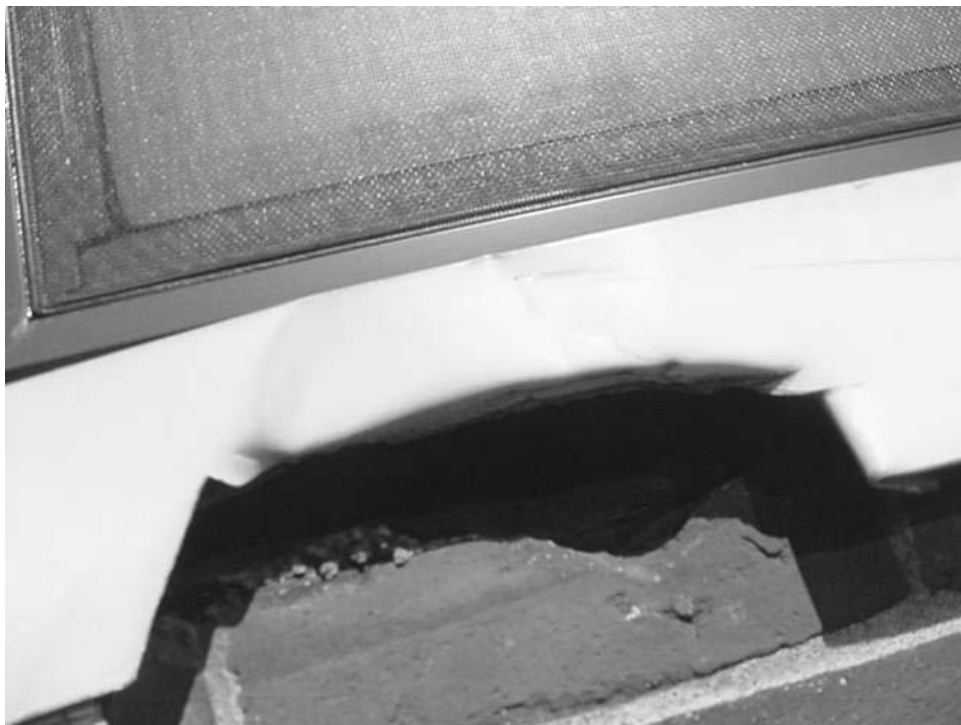
Picture 14

Damaged metal window siding

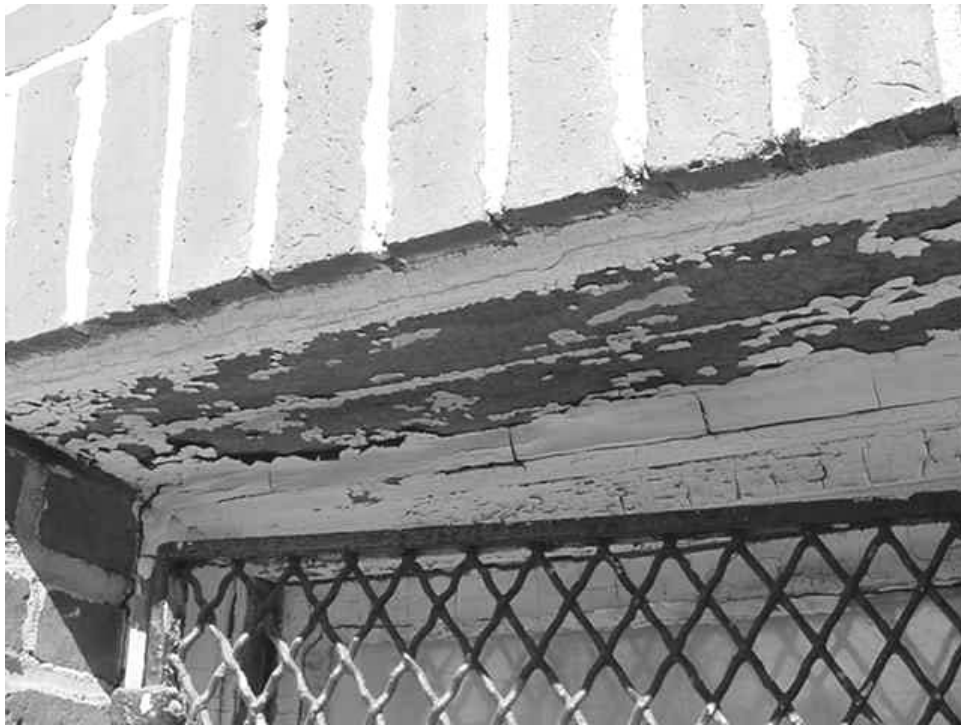
Picture 15

Breaches to the window frame

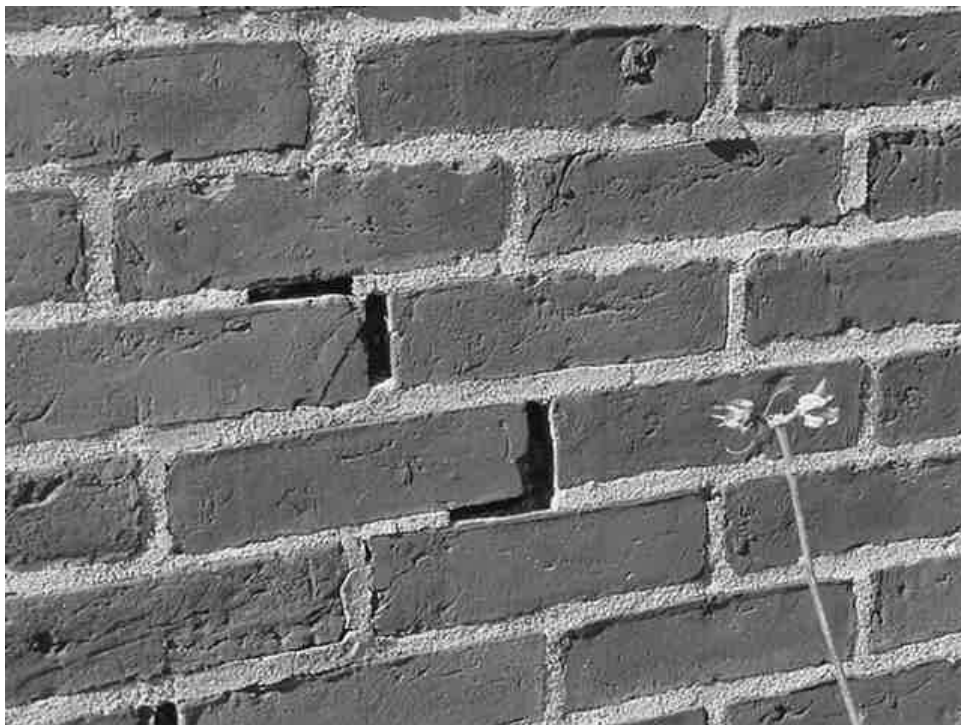
Picture 16

Missing mortar

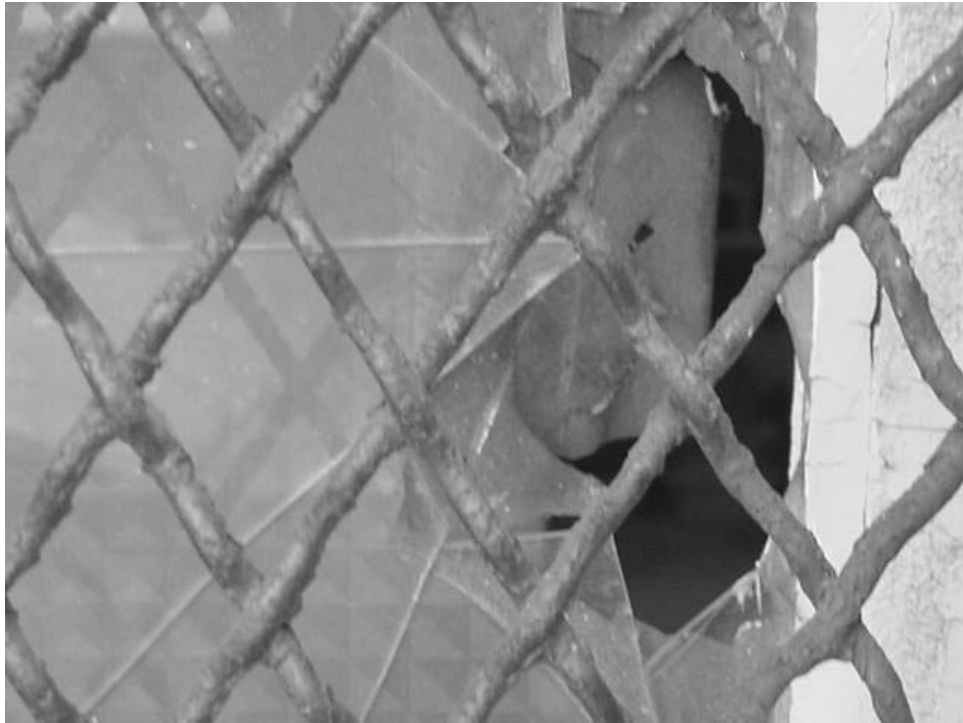
Picture 17

Broken window

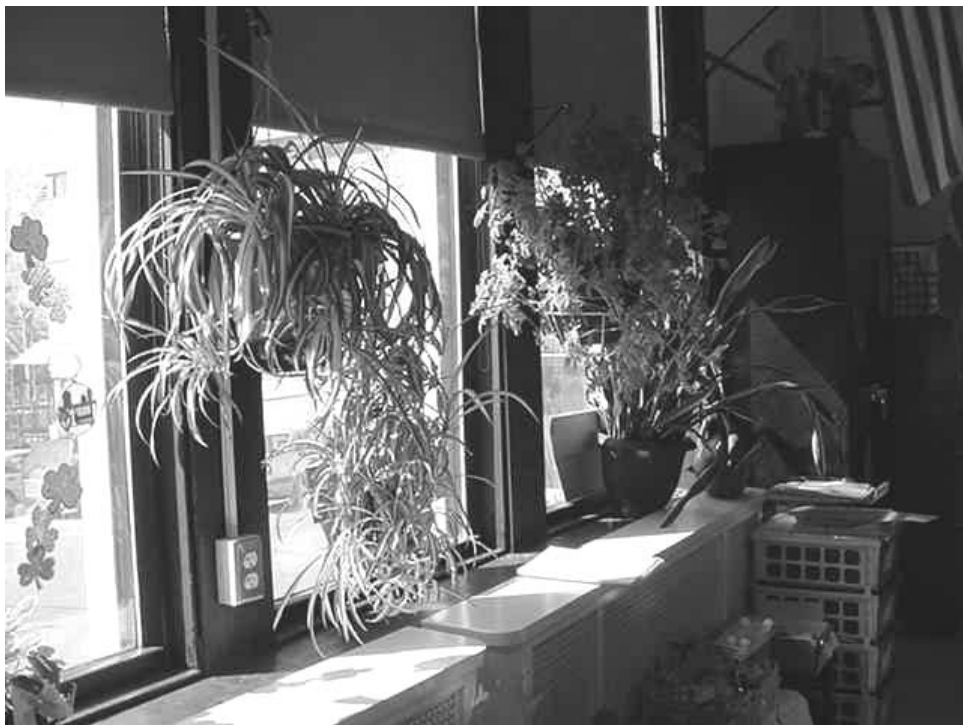
Picture 18

Plants were located in several classrooms (Picture 18). Plants can be a source of pollen and mold, which can be respiratory irritants for some individuals. Plants should be properly

Plants

maintained and equipped with drip pans to prevent moistening and potential mold growth to porous building materials.

16. Empty standing water from planters and/or move away from univent fresh air intakes.
17. Remediate damaged floor tiles in conformance with Massachusetts asbestos remediation and hazardous waste disposal laws.

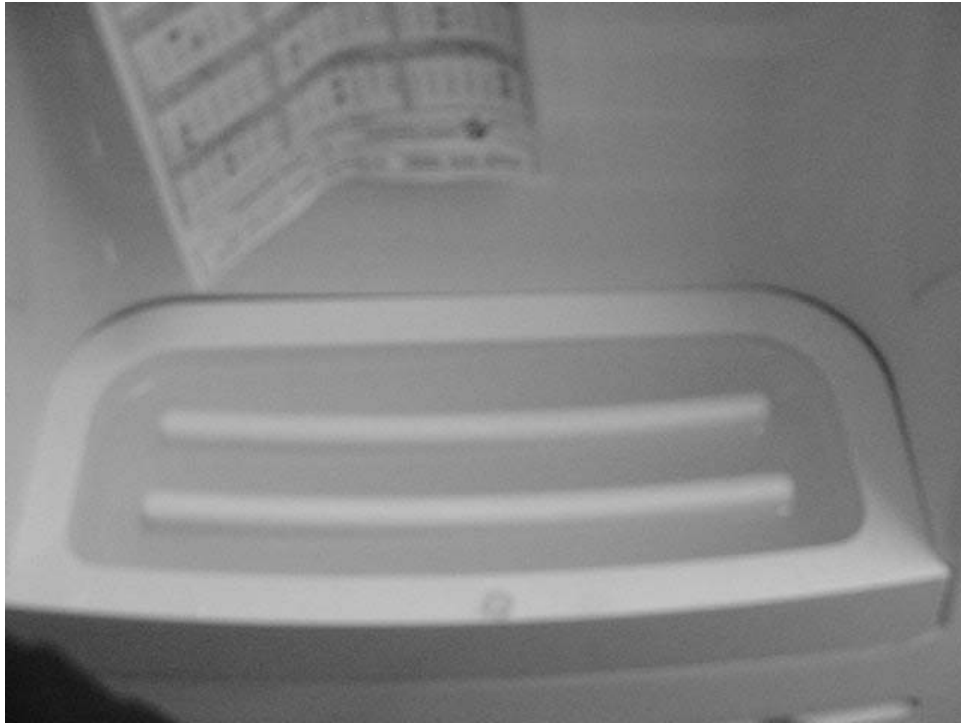
Picture 19

Lastly, stagnant water was observed in the catch basin of a water cooler (Picture 19). Stagnant water can be a source of odors, and materials (i.e., dust) collected in the water can provide a medium for mold growth. Water basins should be emptied and cleaned periodically to prevent growth and odors.

Standing water in catch basin

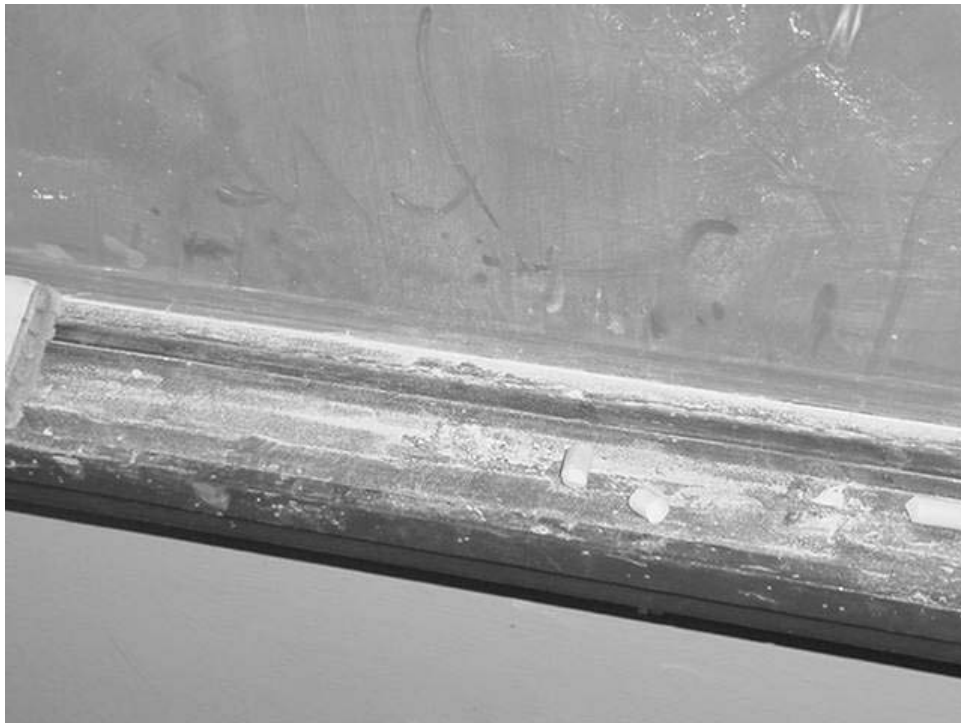
Picture 20

Several other conditions that can affect indoor air quality were observed during the assessment. Accumulated chalk dust was noted in some classrooms (Picture 20). Chalk dust is a fine particulate, which can be easily aerosolized and is an eye and respiratory irritant. Similarly, pencil shavings were observed accumulated at the base of pencil sharpeners and other surfaces. Pencil shavings can become airborne, providing a source for eye and respiratory irritation.

Accumulated chalk dust

19. Clean chalkboard/dry erase marker trays and pencil sharpeners regularly to prevent the build-up of excessive chalk dust and particulates.
20. Replace missing ceiling tiles and refrain from hanging objects from the ceiling tile system to prevent the egress of drafts, odors and particulate matter into occupied areas.

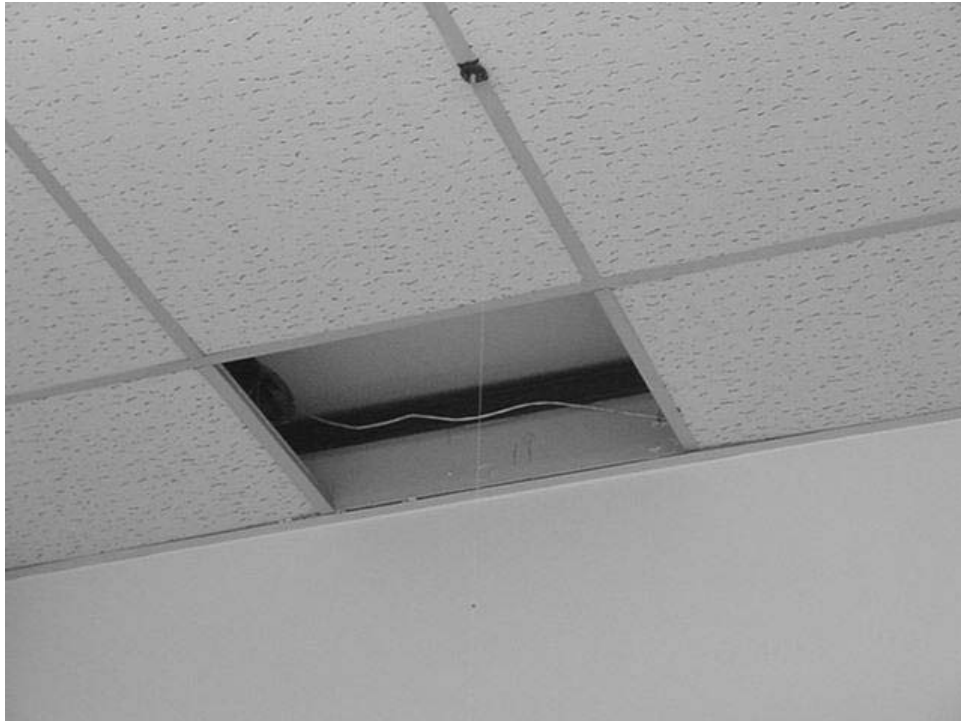
Picture 21

Missing ceiling tiles (Picture 21) and items hanging from ceiling tiles were seen in a few areas. Missing or movement of ceiling tiles can result in the movement of dust, dirt, odors and other pollutants to occupied areas. Dust can be irritating to the eyes, nose and respiratory system.

Missing ceiling tile, note string suspending item

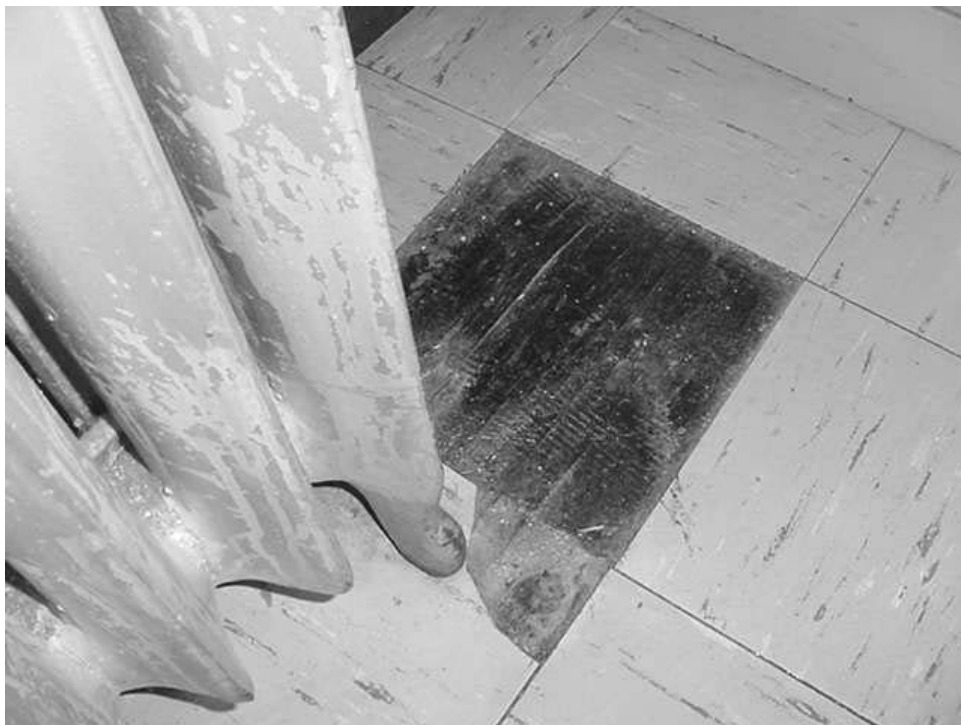
Picture 22

Damaged or missing floor tiles were observed in some areas (Pictures 22). These floor tiles may contain asbestos. Intact asbestos-containing materials do not pose a health hazard. If damaged, asbestos-containing materials can be rendered friable and become aerosolized. Friable asbestos is a chronic (long-term) health hazard, but will not produce acute (short-term) health effects (e.g., headaches) typically associated with buildings believed to have indoor air quality problems. Where asbestos-containing materials are found damaged, these materials should be removed or remediated in a manner consistent with Massachusetts asbestos remediation laws (MDLI, 1993).

Missing floor tile

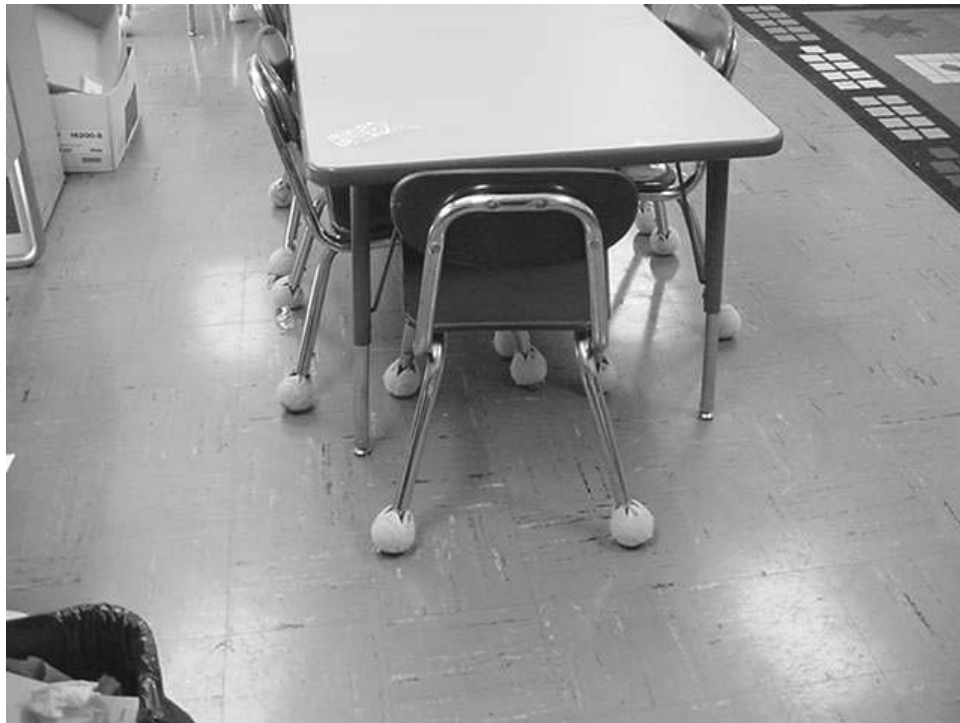
Picture 23

Lastly, in an effort to reduce noise from sliding chairs, tennis balls had been sliced open and placed on chair legs (Picture 23). Tennis balls are made of a number of materials that are a source of respiratory irritants. Constant wearing of tennis balls can produce fibers and off gas VOCs. Tennis balls are made with a natural rubber latex bladder, which becomes abraded when used as a chair leg pad. Use of tennis balls in this manner may introduce latex dust into the school environment. Some individuals are highly allergic to latex (e.g., spina bifida patients) (SBAA, 2001). It is recommended that the use of materials containing latex be limited in buildings to reduce the likelihood of symptoms in sensitive individuals (NIOSH, 1997). A question and answer sheet concerning latex allergy is attached as [Appendix B](#) (NIOSH, 1998b).

Tennis balls on chair legs

21. Consider replacing tennis balls with felt bottomed alternative “glides” (Picture 24).

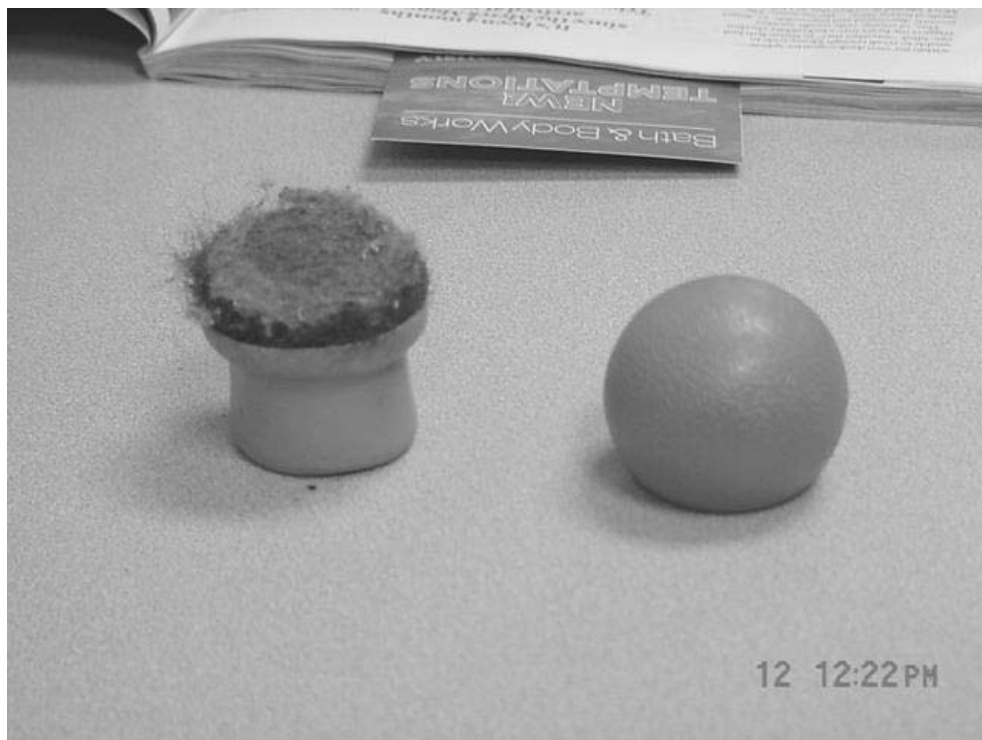
Picture 24

Alternative“glides” that can be used in place of tennis balls on chair legs
